Technical Memorandum A

# Comprehensive Sign Plan for Town Center

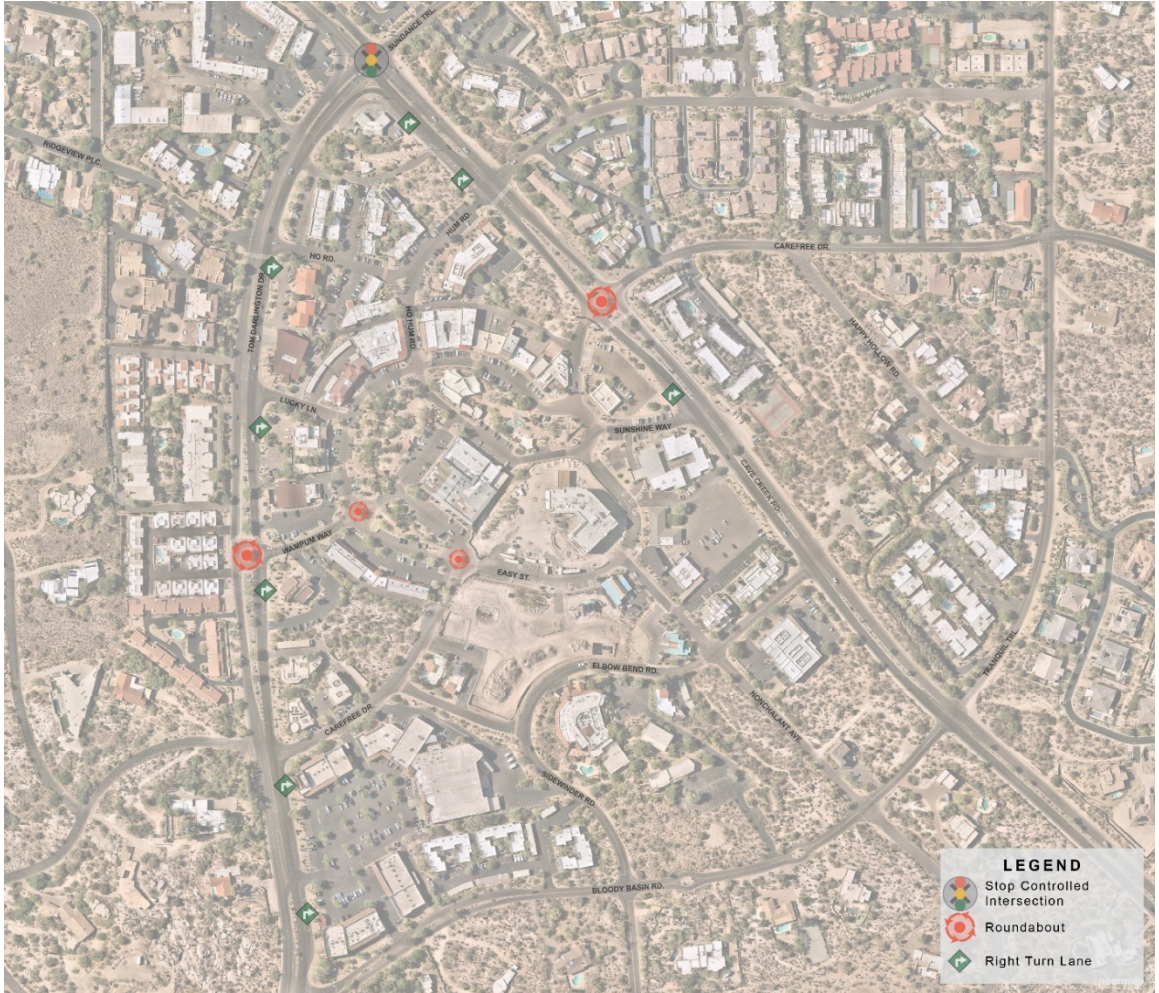
**FIGURE 1 – EXISTING TRAFFIC CIRCLES AND STOPLIGHTS**

- There are two existing, one-way traffic circles along the arterial roadways. The traffic circles have “gateway” architectural elements and serve as the primary entrance points to the Town Core. Two internal traffic circles exist as well. It was observed from a driver perspective that the traffic circles detract and divert attention away from the Gateway entrances to the Town Core.

- The traffic circles operate as a free-flow through movement for vehicles traveling along the mainline (Tom Darlington Drive and Cave Creek Road, for example). Side-streets operate under stop control. There is yield signage in the middle of the circles, meaning any vehicle making a left turn or U-turn from the mainline or entering the circle from the side streets must make a two-stage movement. The combination of this maneuver and the appearance of the traffic circle operating like a roundabout could create an unsafe environment for vehicles.

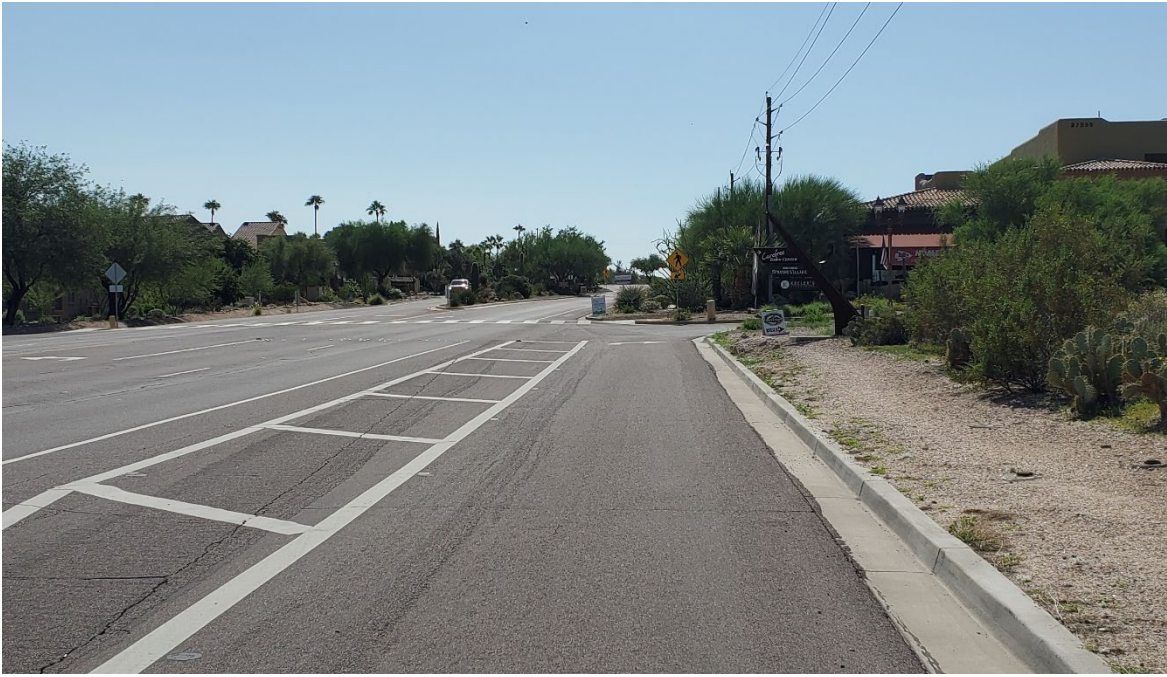
*Existing Turn Lane on Cave Creek Road*

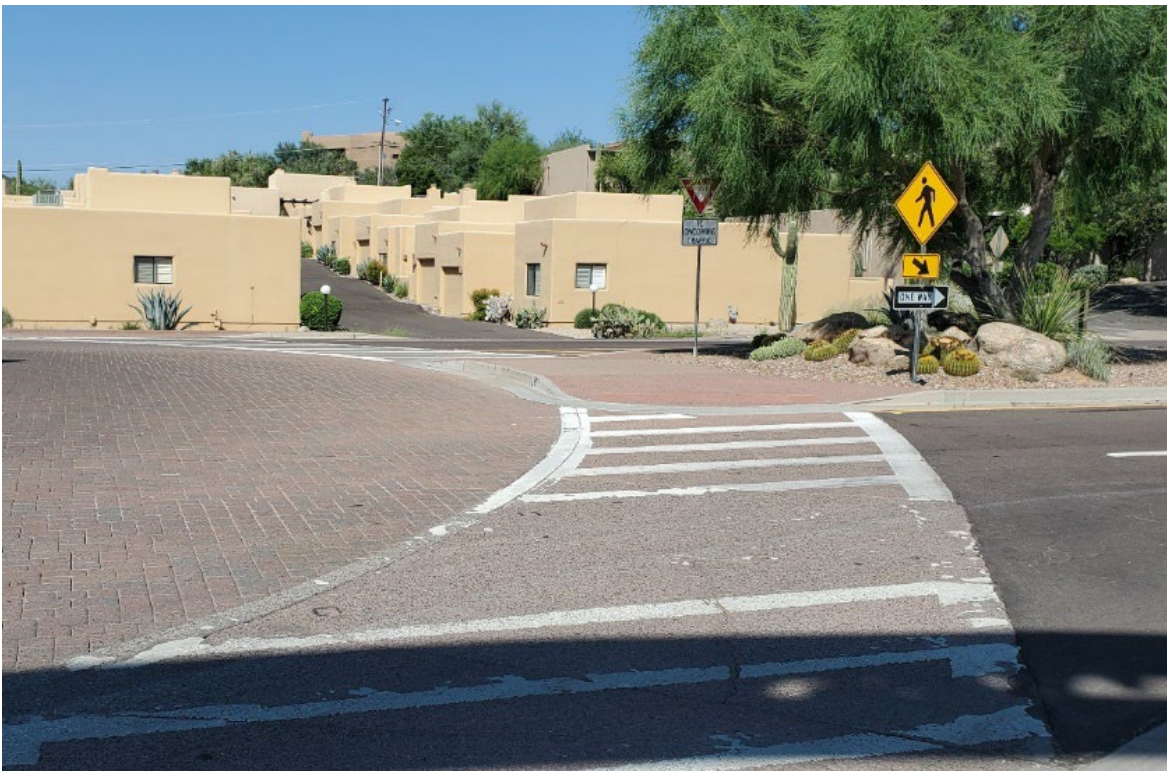
*Existing Crosswalk at Traffic Circle on Tom Darlington Drive*

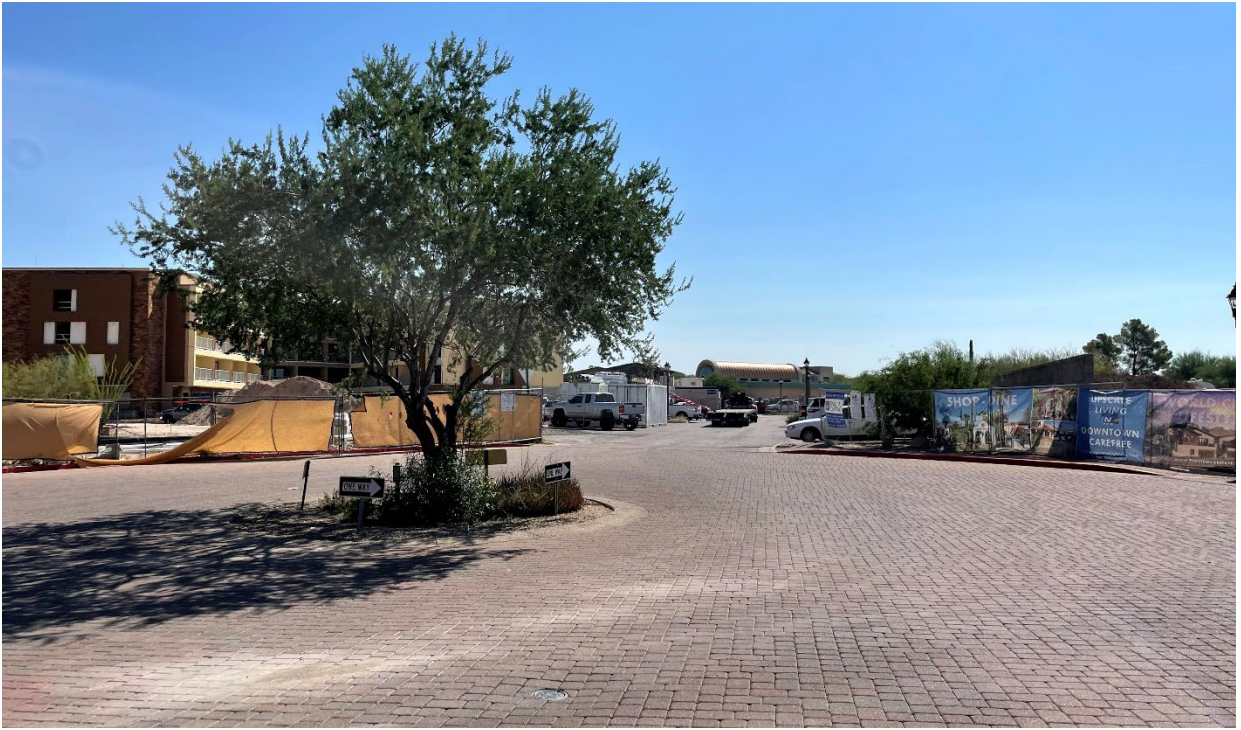
*Existing Traffic Circle Near New Hotel Site on Carefree Drive*

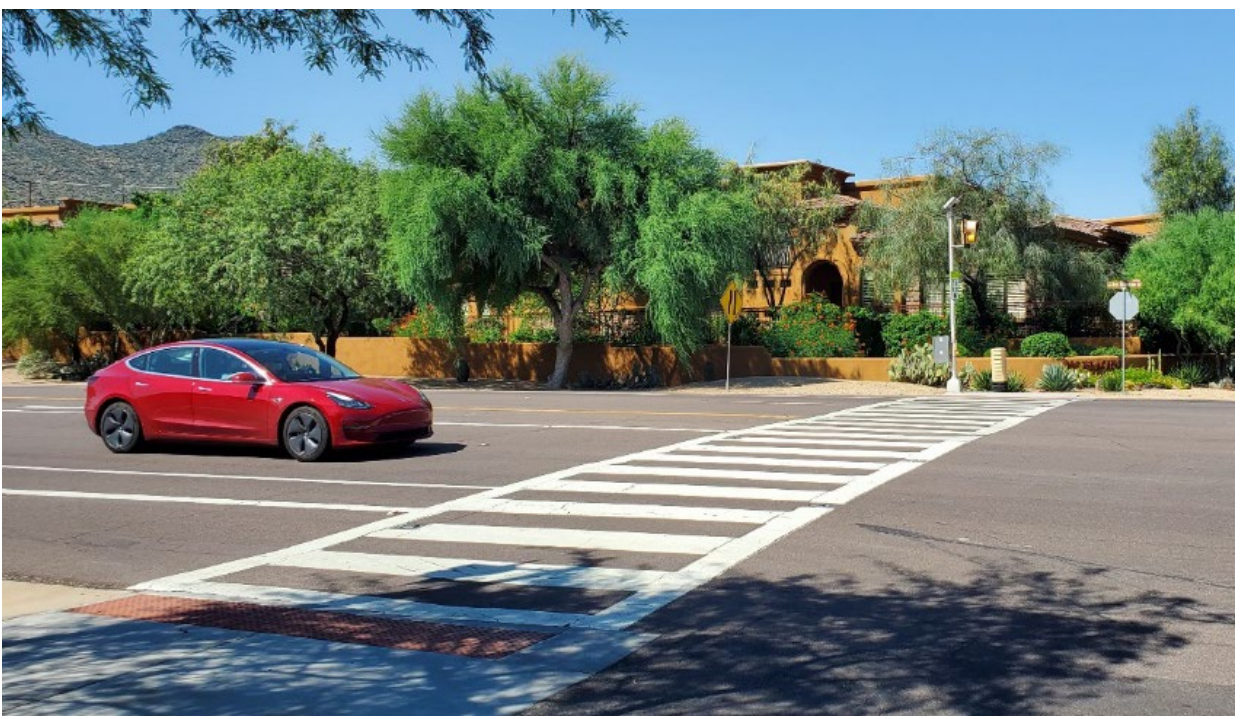
*Existing Signalized Crosswalk on Tom Darlington Drive*

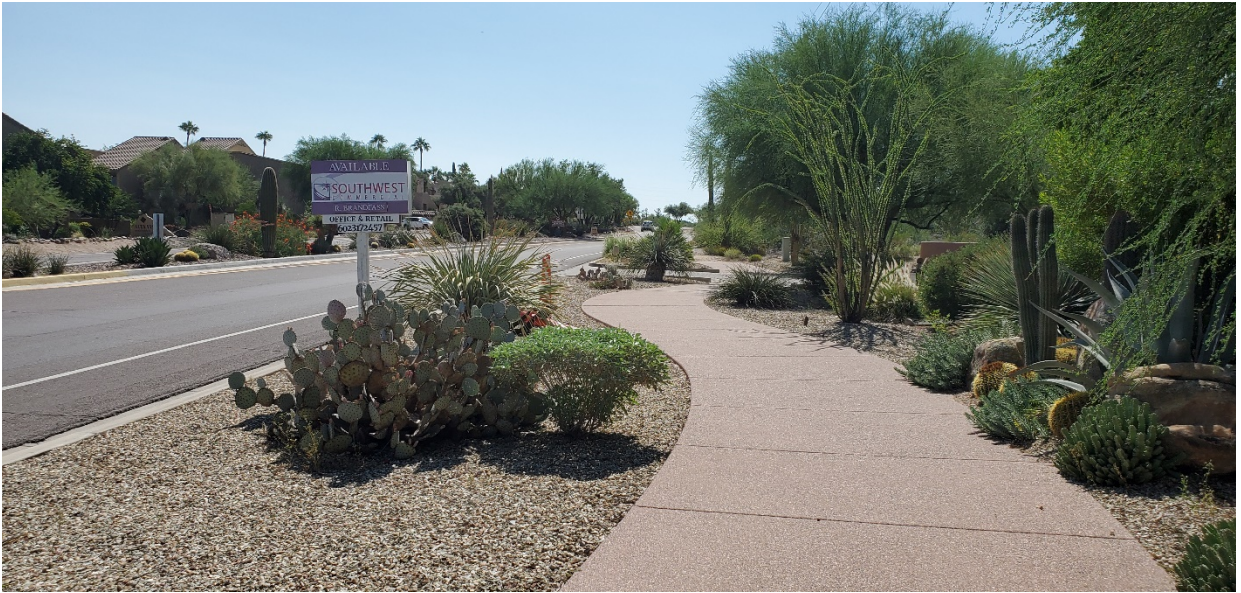
*Existing Section of Sidewalk Along Cave Creek Road*

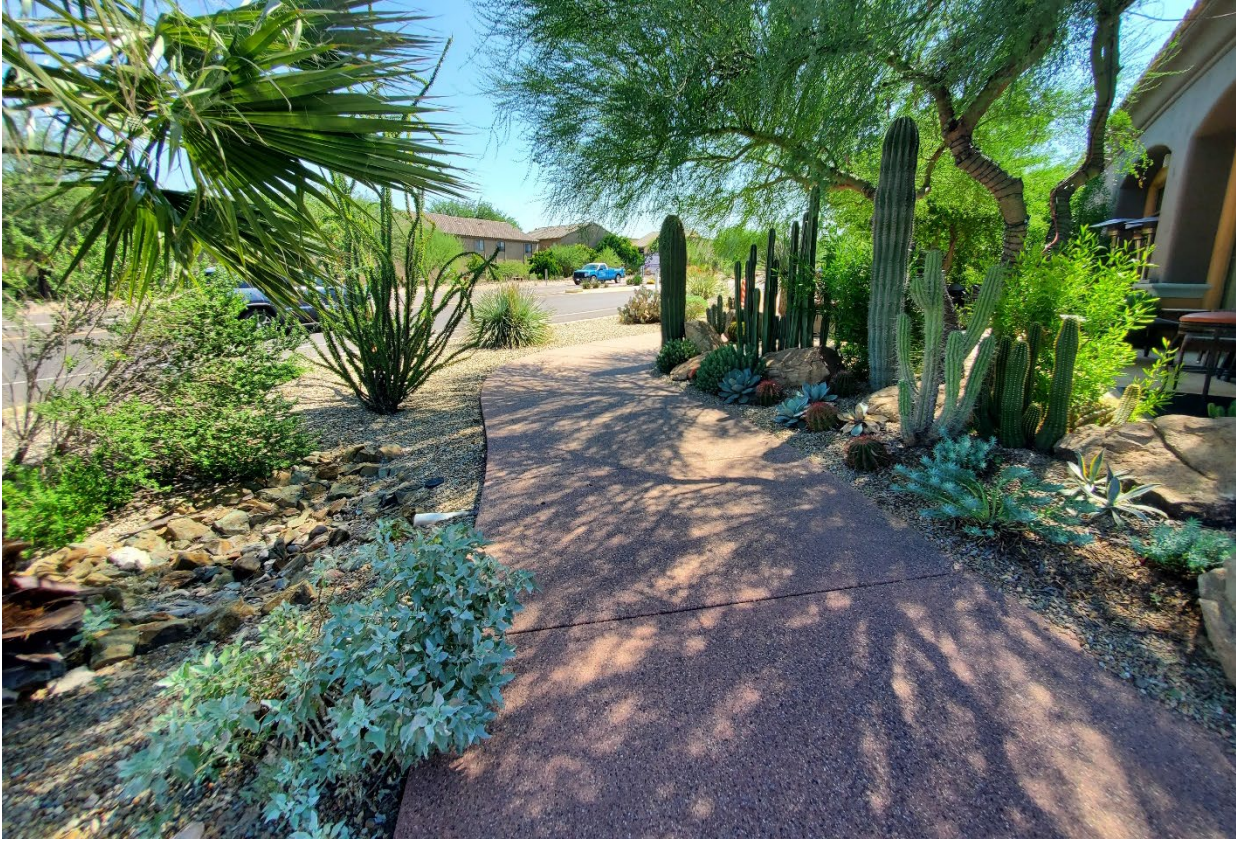
*Example of Landscaping and Shade Along Existing Sidewalk*

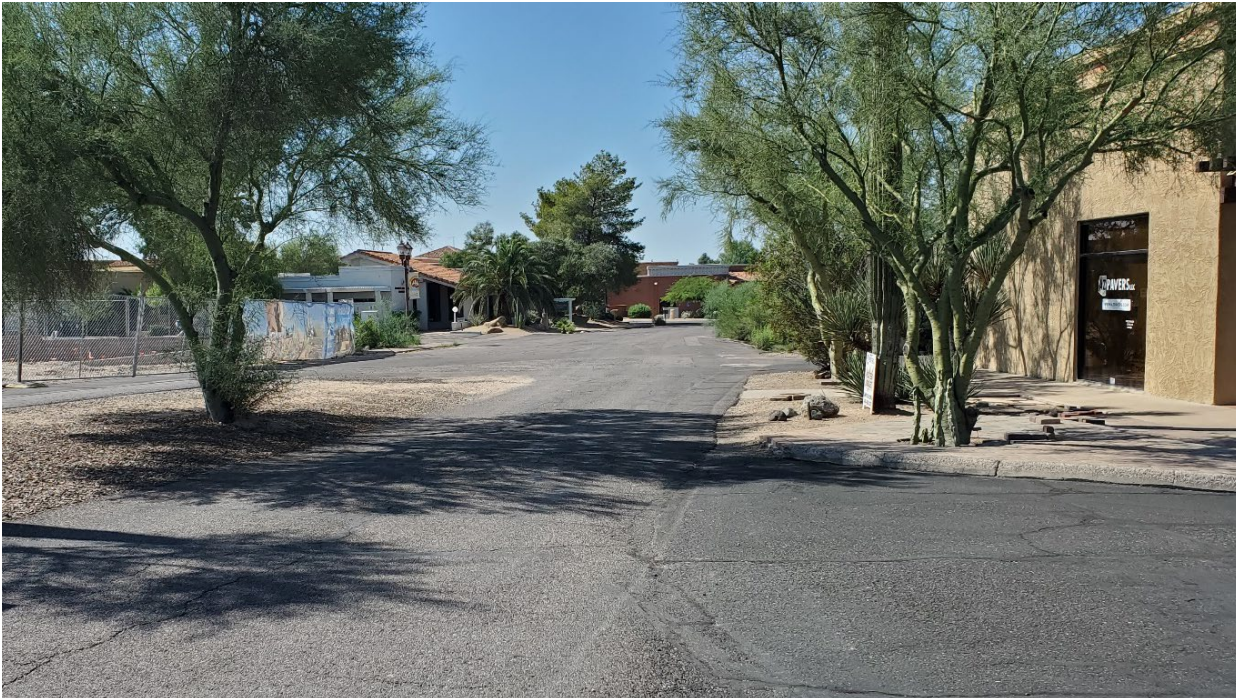
*Carefree Drive Offers Limited Pedestrian Opportunities.*

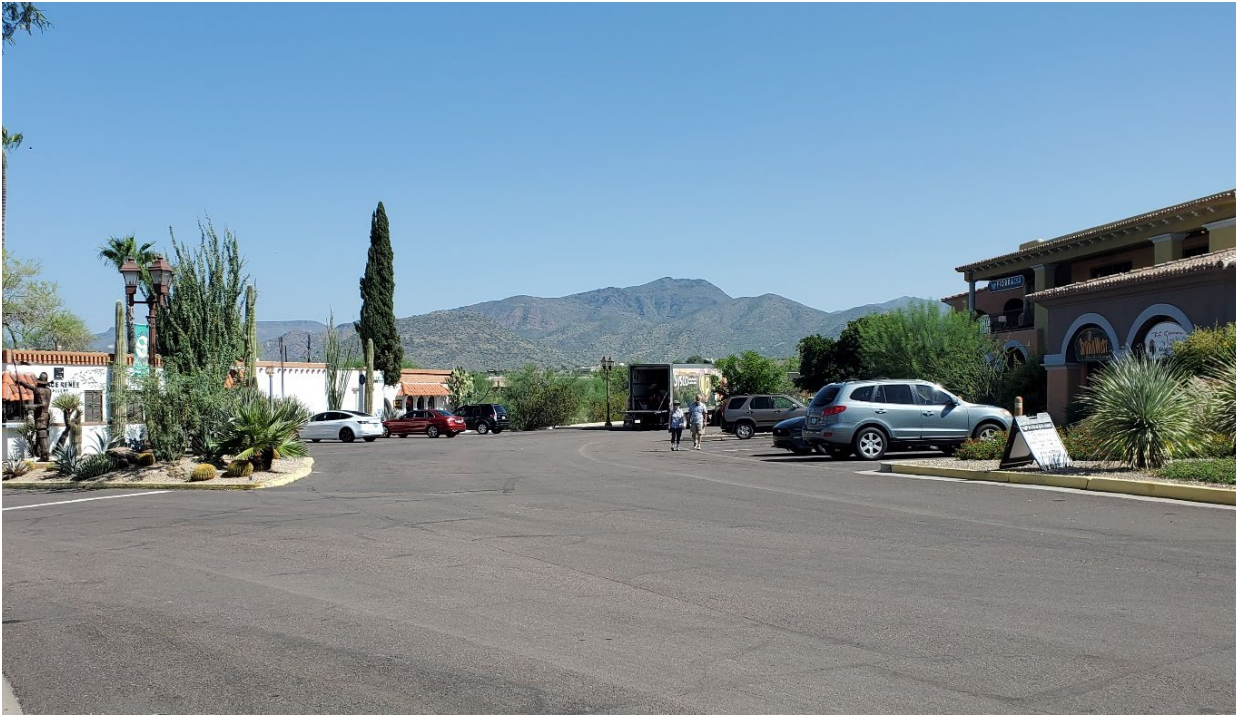
*Visitors Walking Within the Street Due to Lack of Pedestrian Connectivity at Ho Hum Drive.*

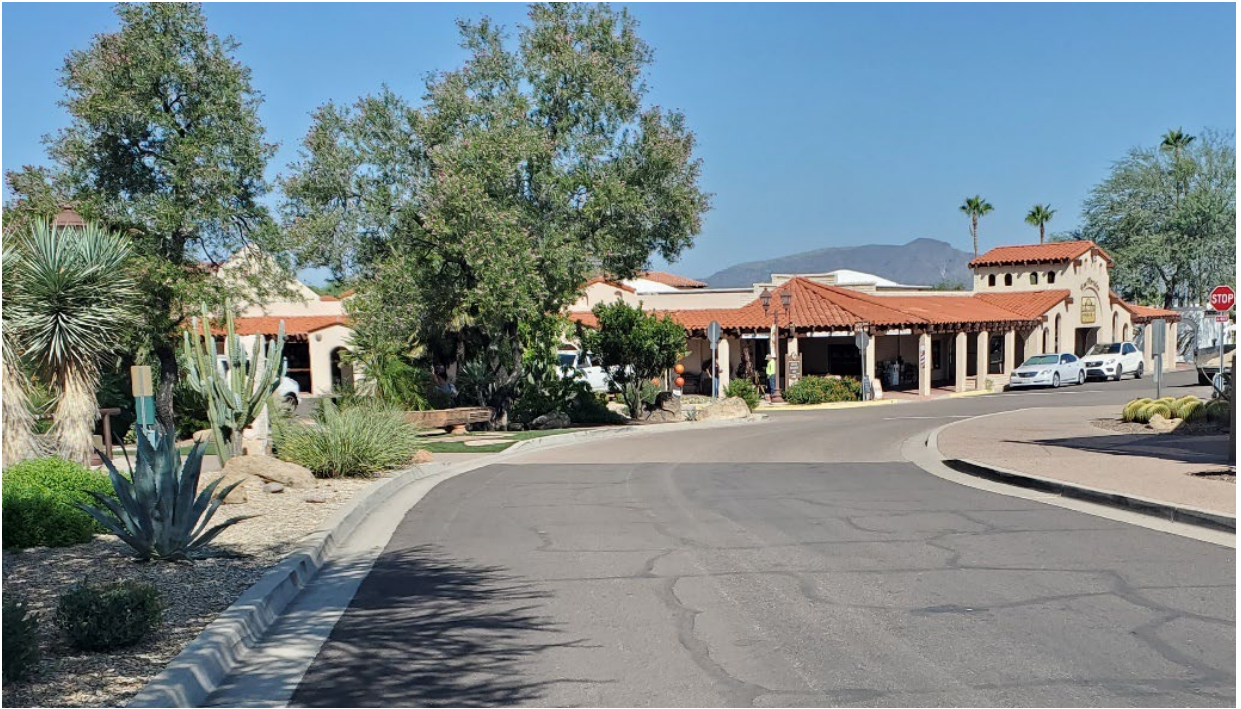
*Limited Pedestrian Opportunities on West Side of Ho Hum Drive.*

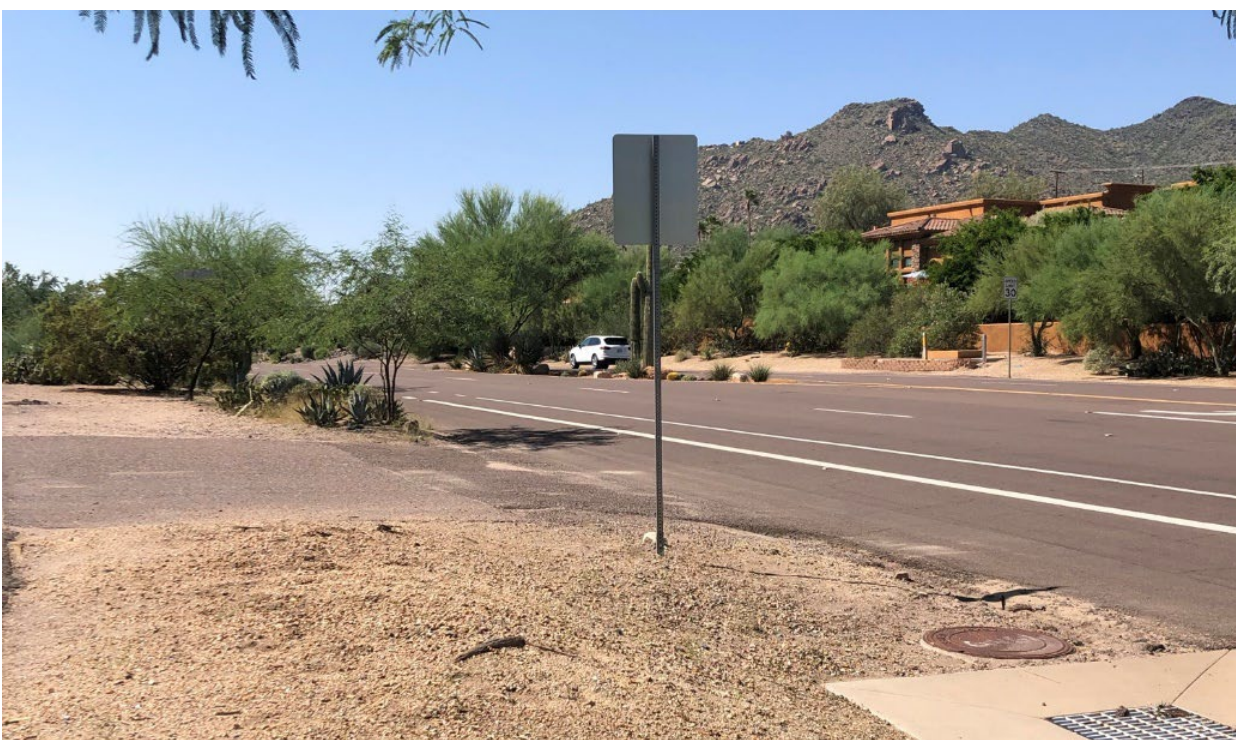
*Lack of Sidewalks Along Tom Darlington Drive.*

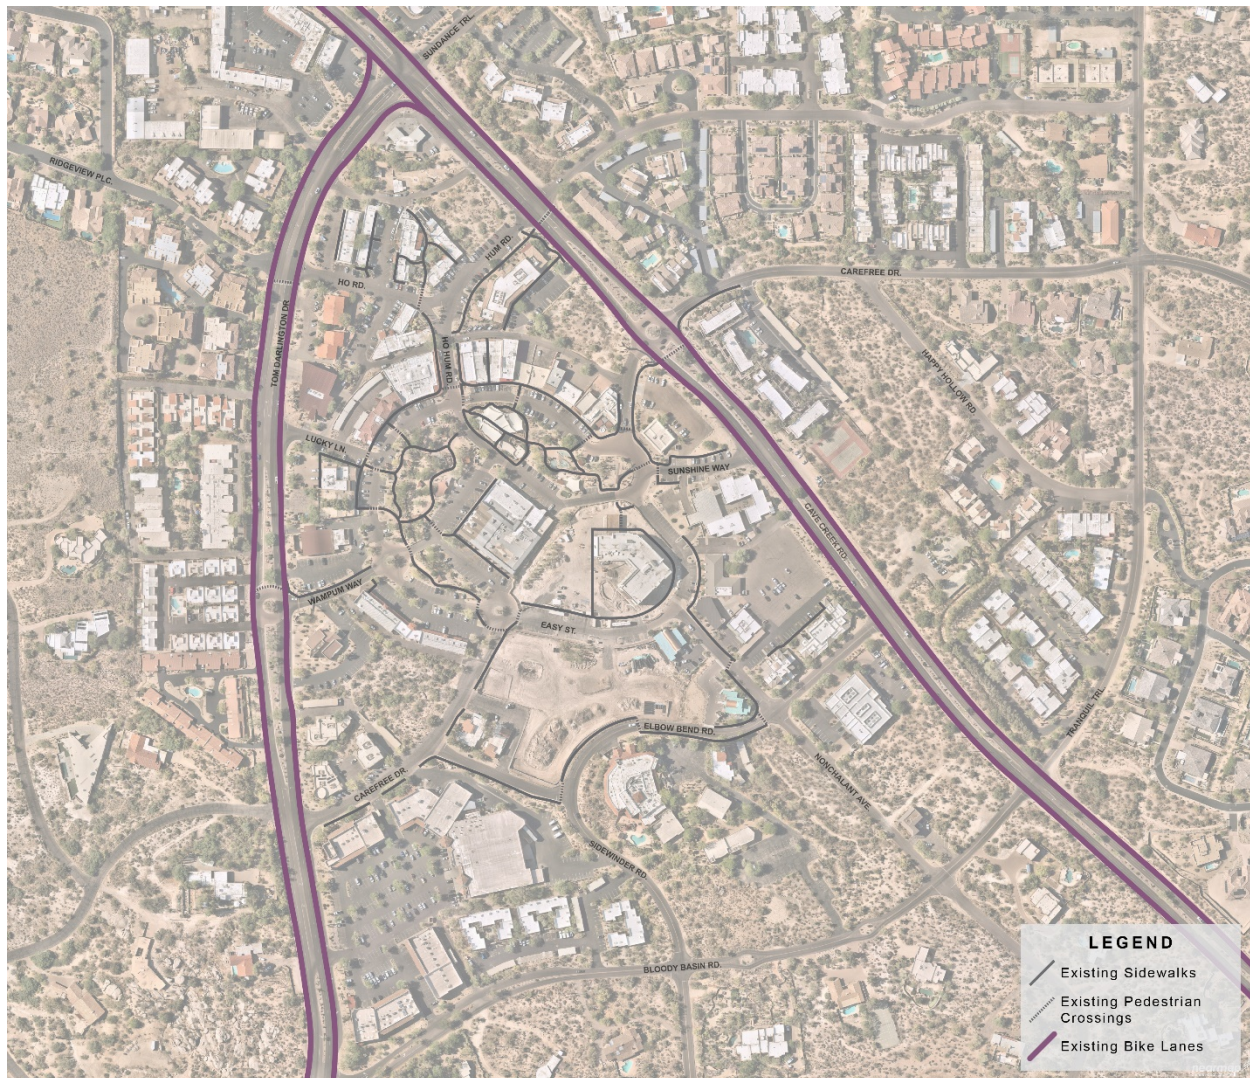
**FIGURE 3 – EXISTING BICYCLE NETWORK**

Bicycle lanes are present on both sides of Tom Darlington Drive from Bloody Basin Drive to Ed Everett Way (**Figure 3**), terminating just prior to the intersection at Tom Darlington Drive and Cave Creek Road. Bicycle lanes are also present on both sides of Cave Creek Road from Bloody Basin Drive to Tom Darlington Drive.

- ▲ Bike lanes must be properly maintained and cleaned to provide bicyclists a clear and safe path.
- ▲ Vehicular traffic along both Tom Darlington Drive and Cave Creek Road travels at high speeds, which makes for an uncomfortable ride for inexperienced riders.

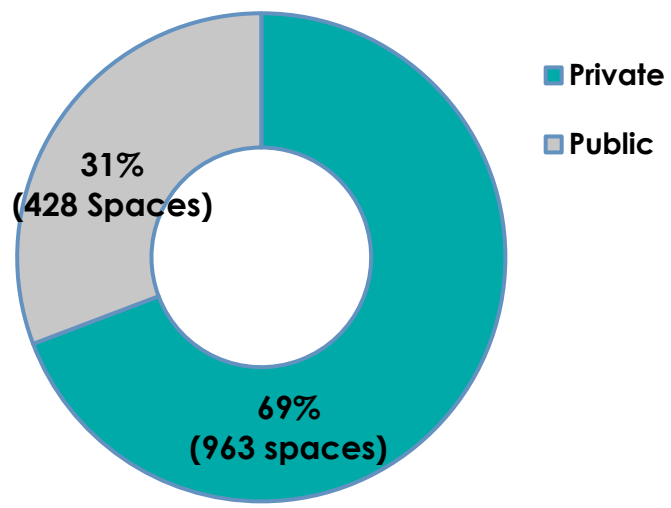
**FIGURE 4 - PERCENT OF PARKING SPACES BY TYPE OF SPACE**

The majority of the parking spaces in the center of Carefree are private as **Figure 4** demonstrates.

While the chart demonstrates that approximately only 30% of the parking assets in the center of town is publicly available, many of the private assets are difficult to access. While they may be within walking distance, that walk may not be the most direct, comfortable, or intuitive. Wayfinding enhancements can optimize the accessibility to some of these private parking assets.

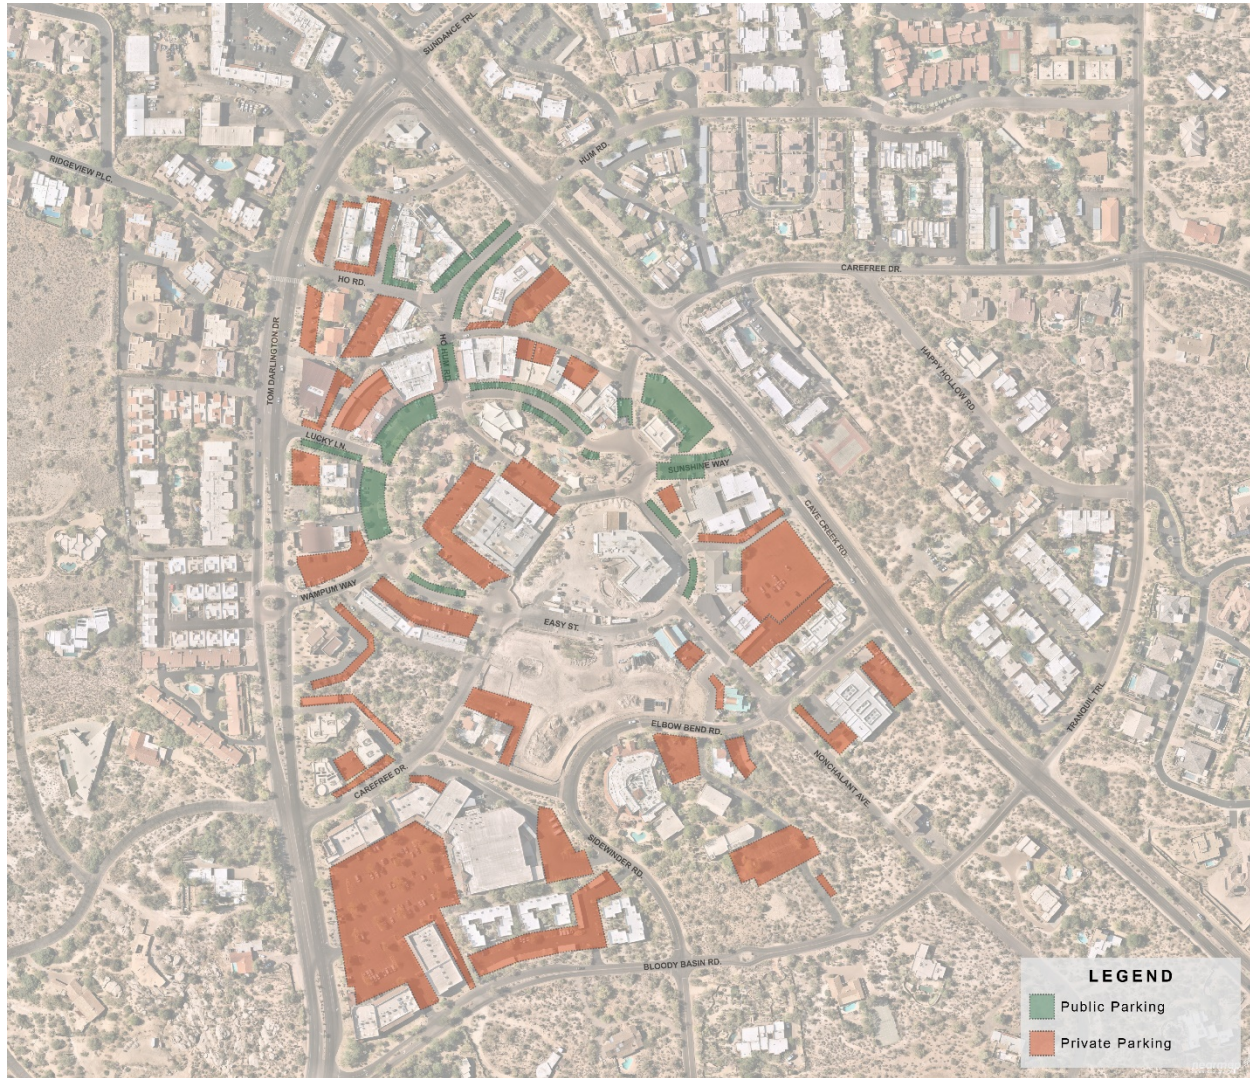
**FIGURE 5 – CAREFREE PARKING ASSETS**

The location of the parking assets and their designation as either public or private is illustrated in **Figure 5**.

As the map demonstrates, the majority of public parking is located in the heart of Carefree. This is essential for supporting the many different businesses in that part of town. The public parking in this part of town enables visitors and employees to park in one location and visit multiple destinations, without having to move their vehicle. The private parking, slightly further away from the heart of town, provides visitor and employee parking for those specific destinations.

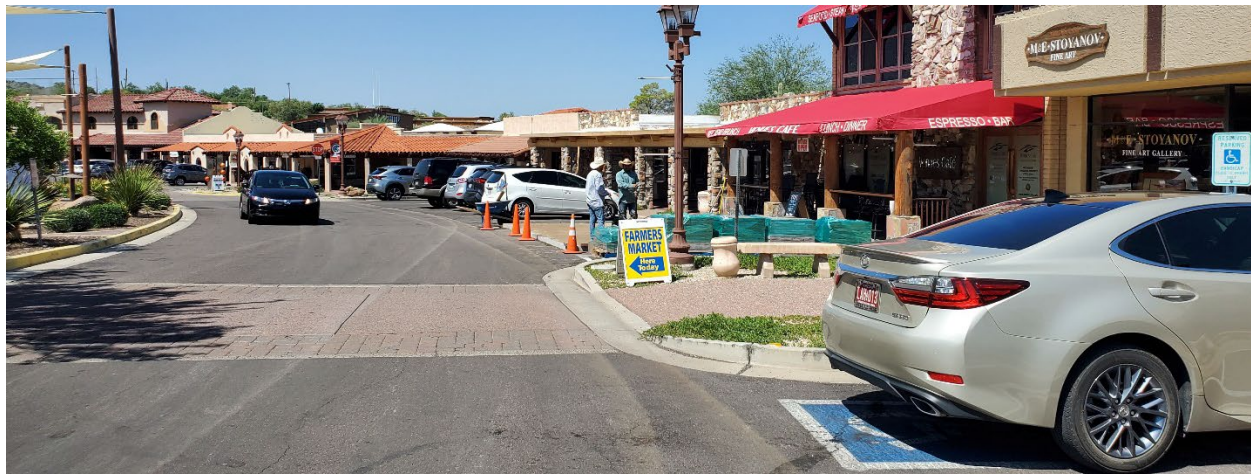
**FIGURE 6 – TYPICAL PARKING UTILIZATION**

In the map shown in **Figure 6**, the parking availability is shown on typical Friday when the Farmer’s Market was occurring. The intent of this map is to illustrate the parking “hotspots” in town and areas where wayfinding can be used to direct traffic and pedestrians more efficiently

to make use of the existing, under capacity parking locations. The hope is that by distributing the demand, parking becomes more available in the town center as well.

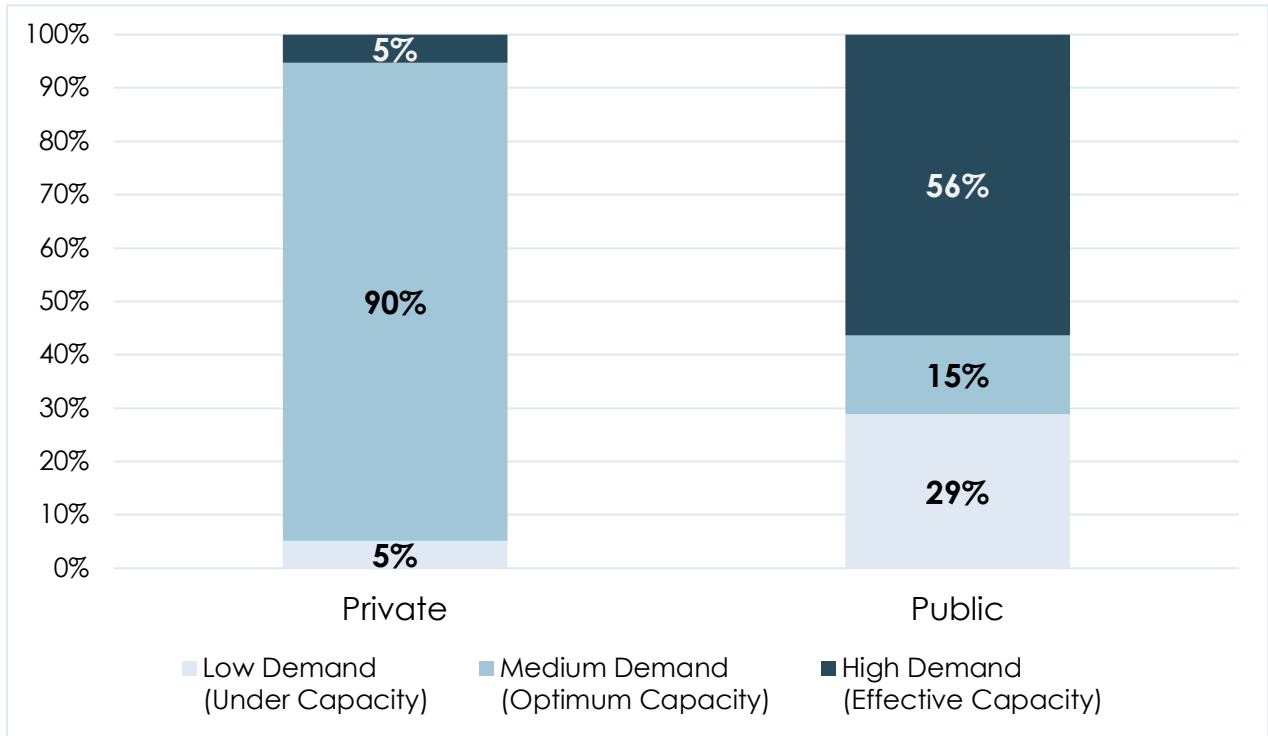
**FIGURE 7 - PERCENTAGE OF SPACES IN HIGH, MEDIUM, AND LOW DEMAND PARKING AREAS**

To put this in perspective on how many spaces are at effective capacity vs under capacity, **Figure 7** provides this comparison.

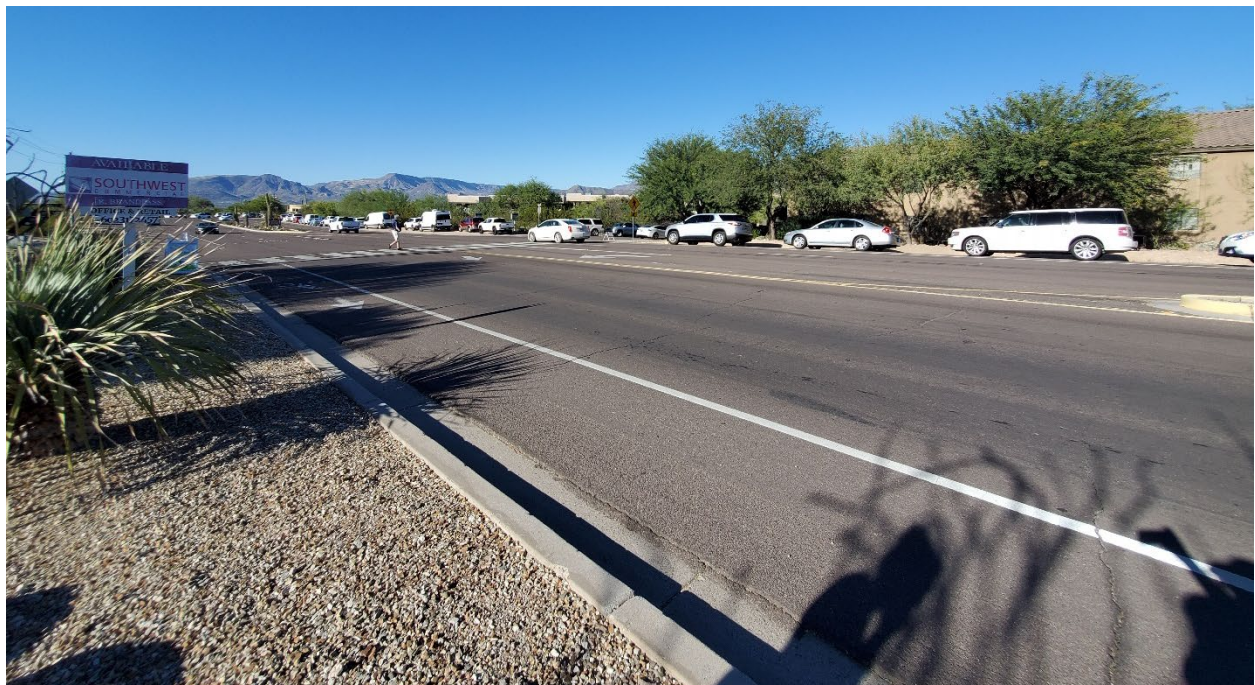
**FIGURE 8 – MAP OF PARKING UTILIZATION DURING THE THUNDERBIRD EVENT**

The map shown in **Figure 8** illustrates the parking demand conditions during the Thunderbird event on November 7, 2021.

The parking in the town center may be sufficient to absorb and accommodate new demands on typical days and when a large event is not occurring. However, when there is a large event, such as the Thunderbird event, the availability of parking assets becomes severely constrained. Improved wayfinding and circulation enhancements would allow for a substantial improvement to the parking situation during an event so that event-goers and those accessing businesses alike can find parking.

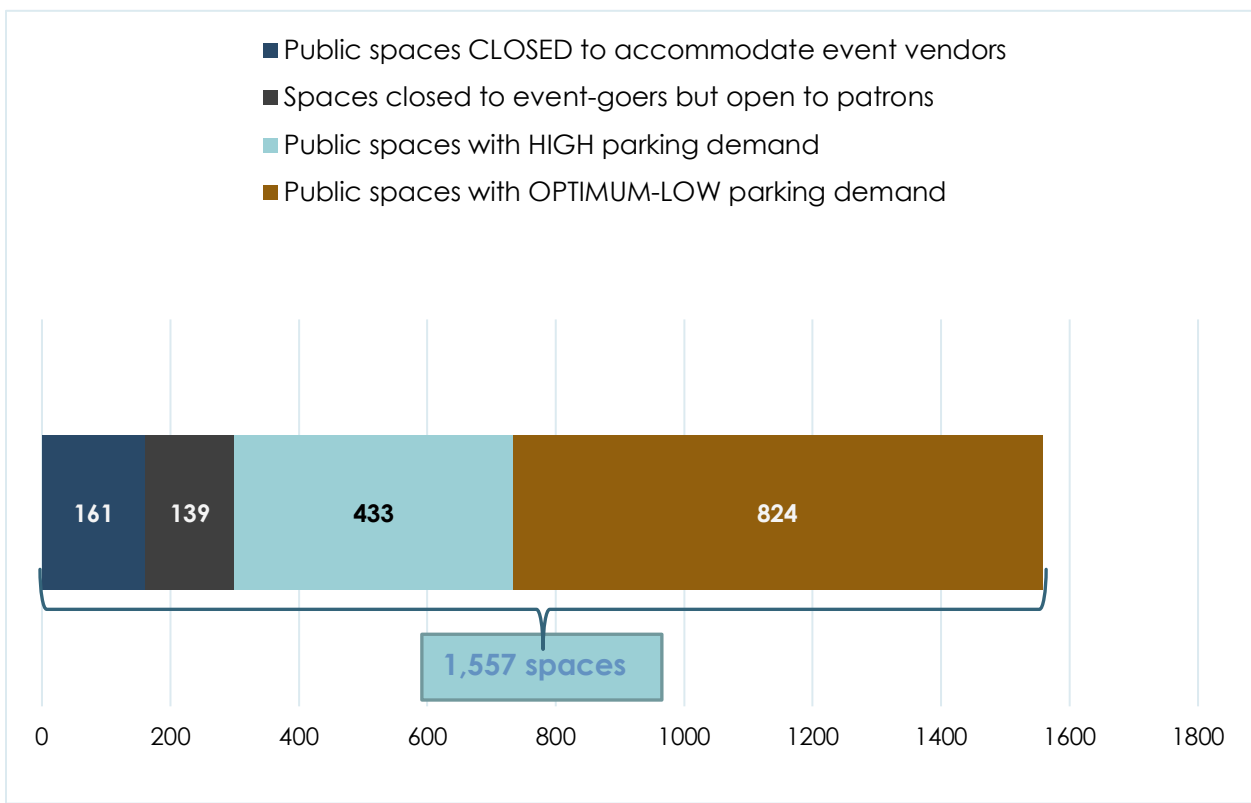
**FIGURE 9 - PARKING OPTIONS DURING EVENT**

Currently, patrons and event-goers must park along the street to access the town center. The unregulated on-street parking can accommodate approximately 100-150 vehicles. It is important to note that this is not the actual number of parked vehicles observed on the street, but an estimate based on the length of curb where vehicles were observed to be parking during the event. **Figure 9** presents a breakdown of parking options during an event, meaning how many spaces are closed for the event to accommodate vendors, how many are open to patrons but not the event, and spaces that are in high vs optimum or low demand. The total number of parking, including the unregulated on-street parking, is 1,557 spaces.

As patrons, event-goers, residents, and employees all navigate the area during an event to try to find available parking, confusion on where to park appropriately becomes an issue. Of the 433 public parking spaces that are in high demand, 100-150 of those are on-street parking that is not normally used. It could be argued that there are enough existing spaces in nearby lots to accommodate that parking need, however, those available spaces are further away from the town center, not easily accessible for a pedestrian, or are privately held for residents and patrons.

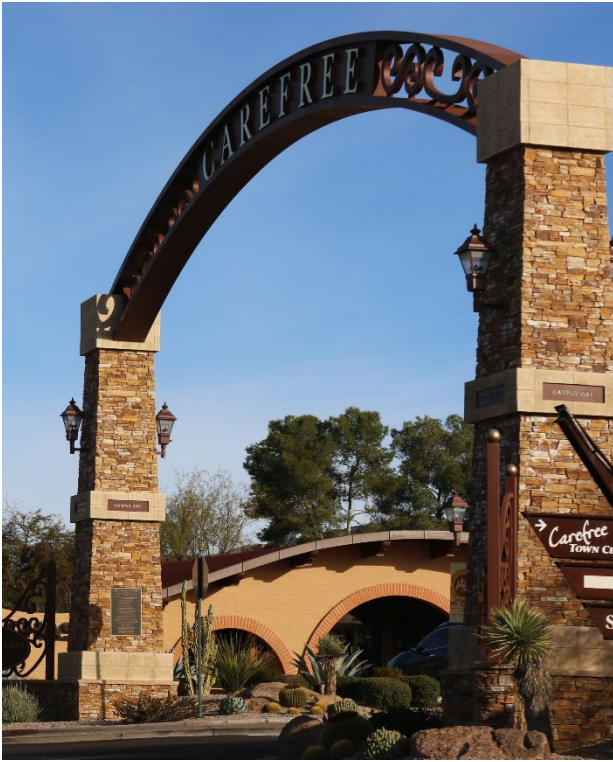
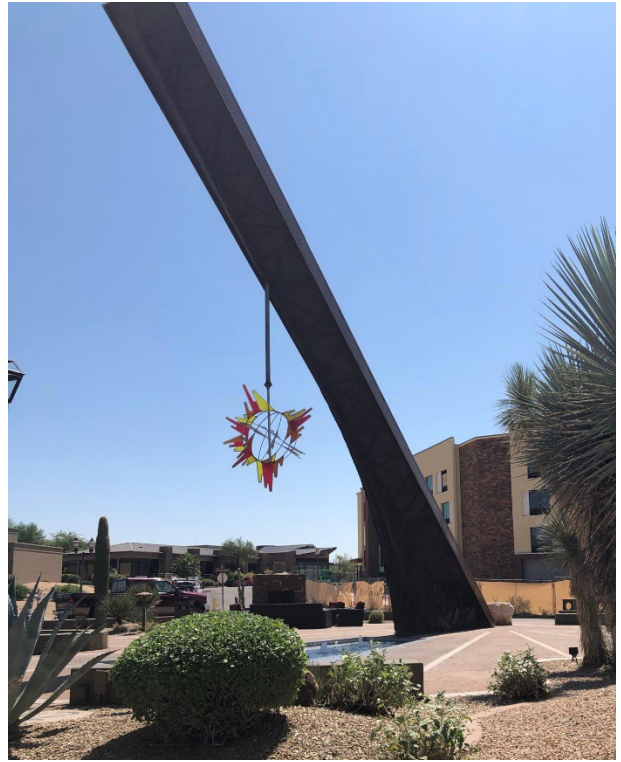
As discussed in the 2015 Michael Baker study, Carefree has facilitated the placement of several well-designed wayfinding signs at each entry road to direct visitors into Town Center. A recommendation that came from this study was to provide a gateway feature at the intended primary entries to Town Center at Wampus Way and Carefree Drive. Unfortunately, when combined with the difficult-to-navigate traffic circles at these locations, the gateway features are not entirely effective in directing passersbys into Town Center. The gateway features are placed parallel to Tom Darlington Drive and Cave Creek Road which makes them difficult to appreciate from a vehicular perspective.

The iconic Sundial also serves as existing gateway signage, marking the center of Town and creating a strong visual centerpiece as a visitor approaches off Cave Creek Road.

*Existing Gateway Signage*

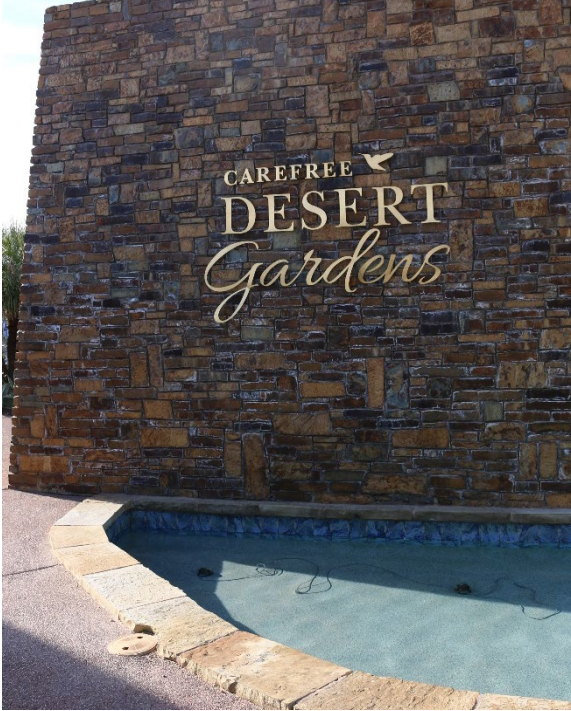
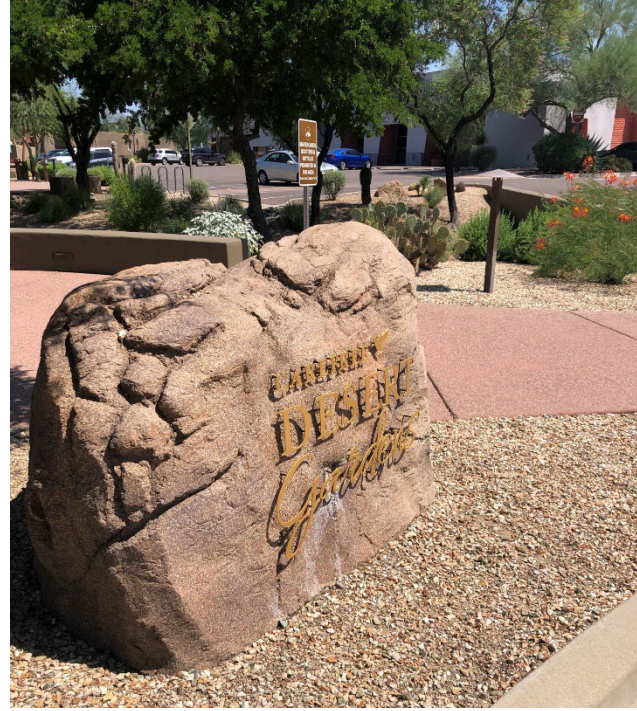
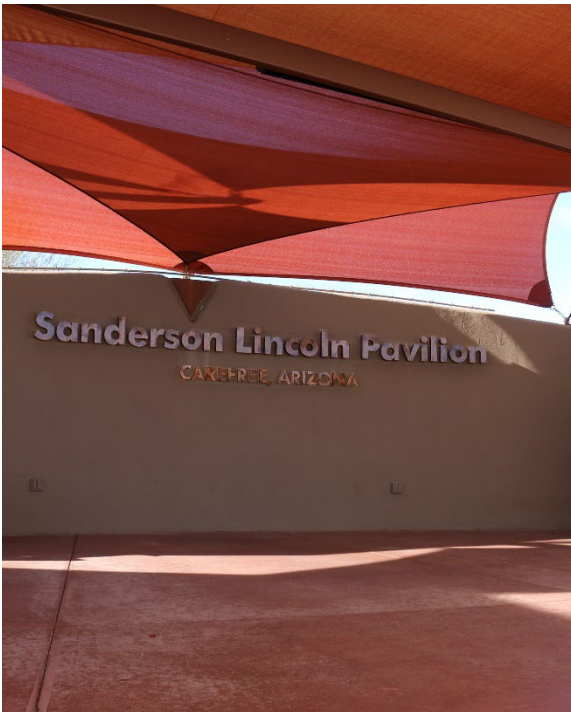
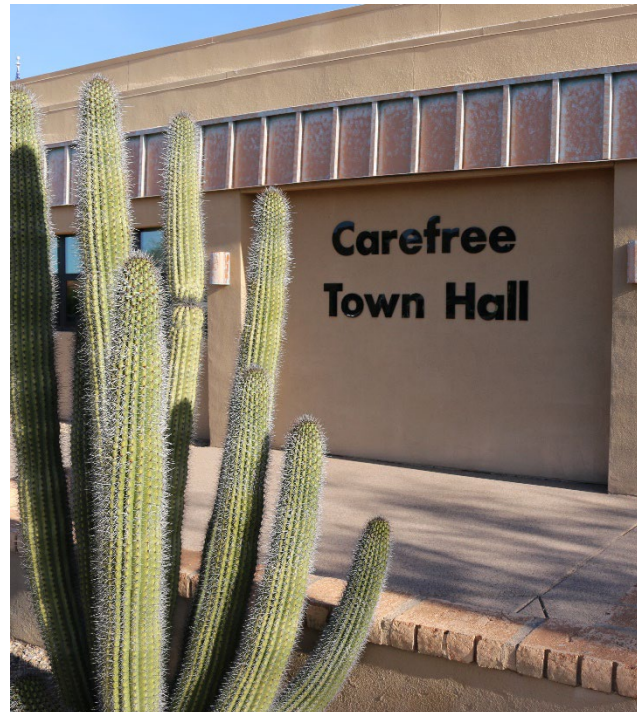
Existing destination signage within Town Center varies significantly. To create a comprehensive look and feel within the area, destination signage should be consistently branded. Signage noting elements within the Carefree Desert Gardens are all similarly branded which creates cohesion and promotes knowing that these items are all part of the same garden experience. Other destination signs such as the building names on Town Hall or the pavilion vary in appearance and color.

Examples of Existing Destination Signs

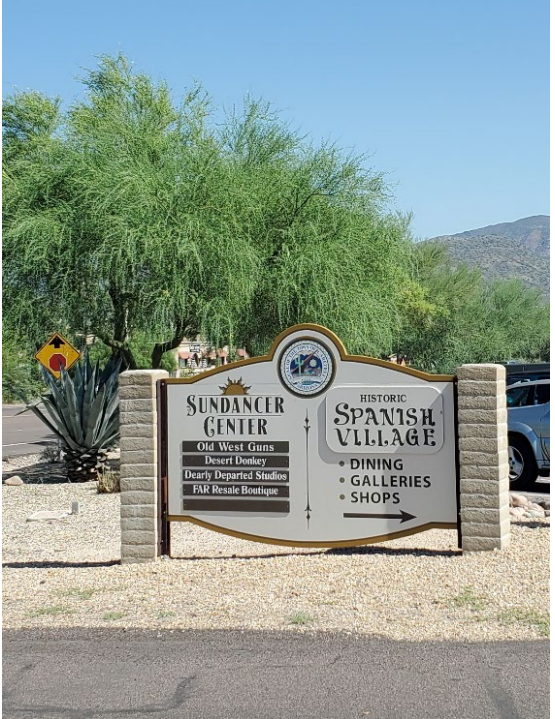
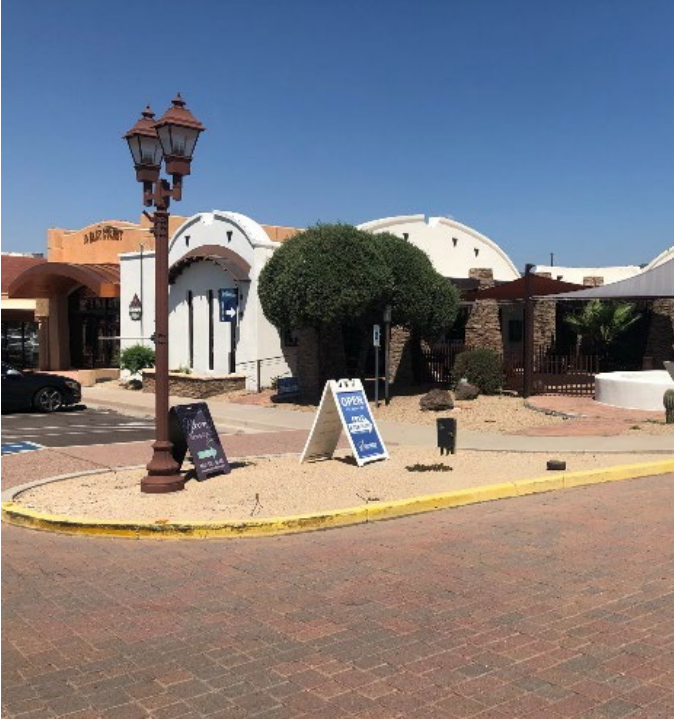
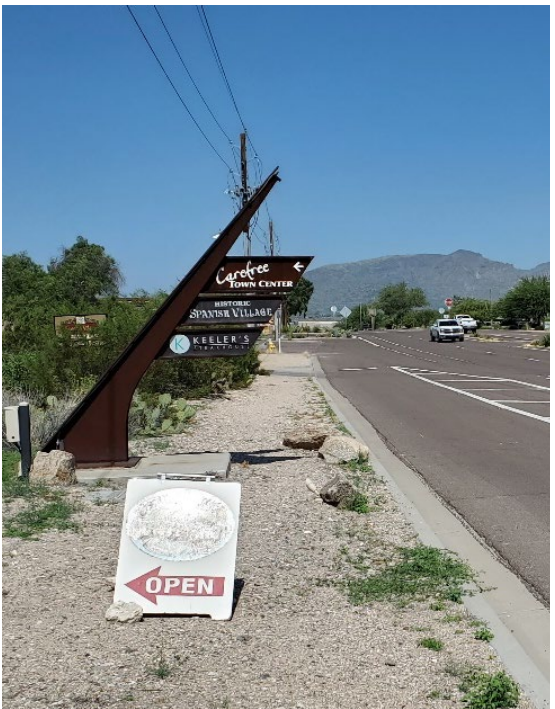
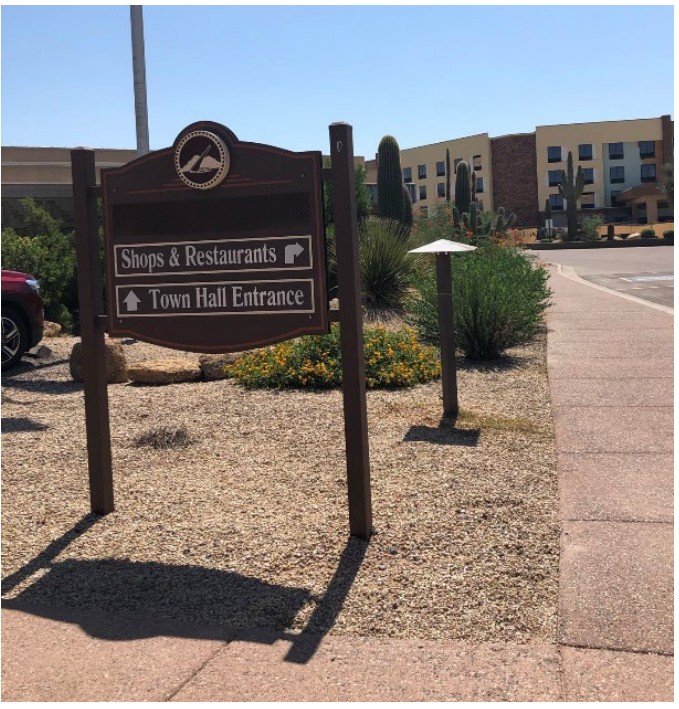
Directional signage within Town Center also varies significantly. There are numerous styles of signs that direct visitors to area businesses or to destinations. In some cases, temporary sandwich boards have been placed to attract visitors to specific businesses. Unfortunately, the effectiveness of these signs can be limited given the amount of sign clutter that these temporary signs often create. Along the arterials, the sundial directional signs blend into the surrounding landscape and are easily overlooked by many visitors as they drive by. Consistency among directional signage is critical to create a comprehensive wayfinding network within the Town along with signage that is easily observed from both a vehicular and pedestrian perspective.

Examples of Existing Directional Signs
