Technical Memorandum A

# Comprehensive Sign Plan for Town Center

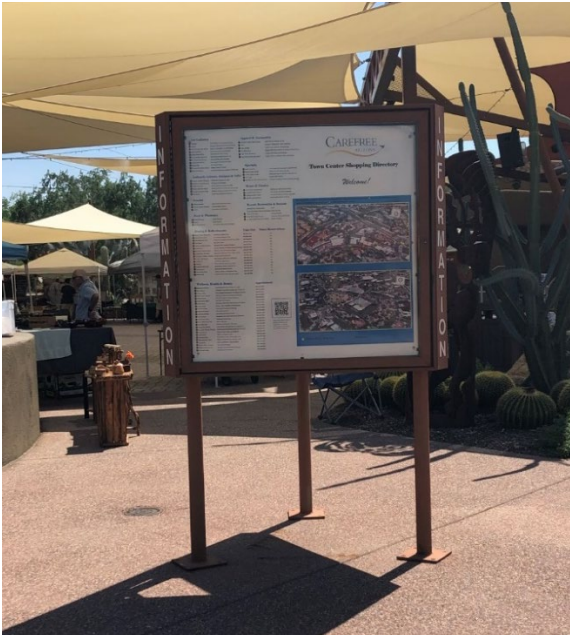
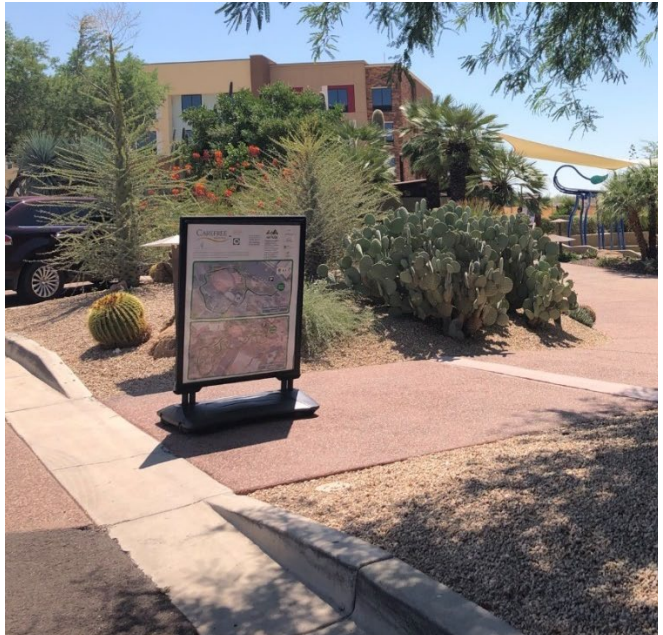
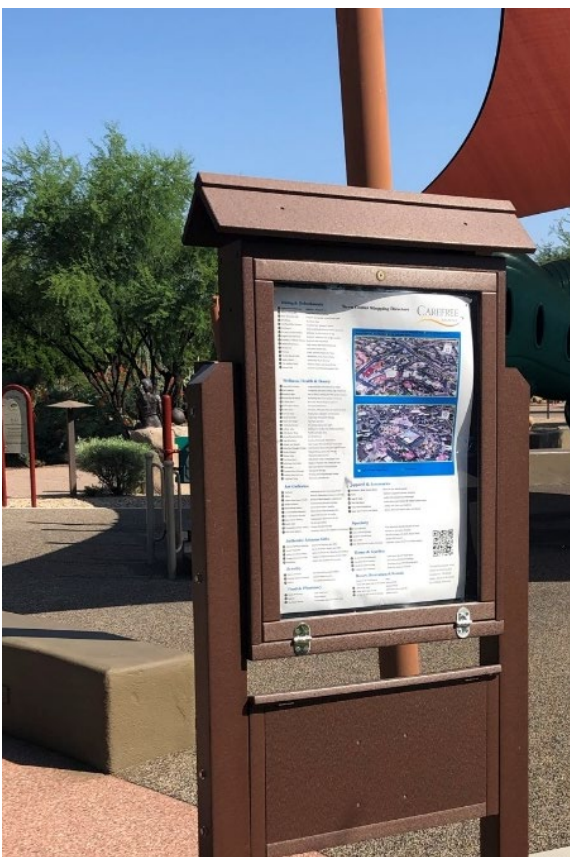
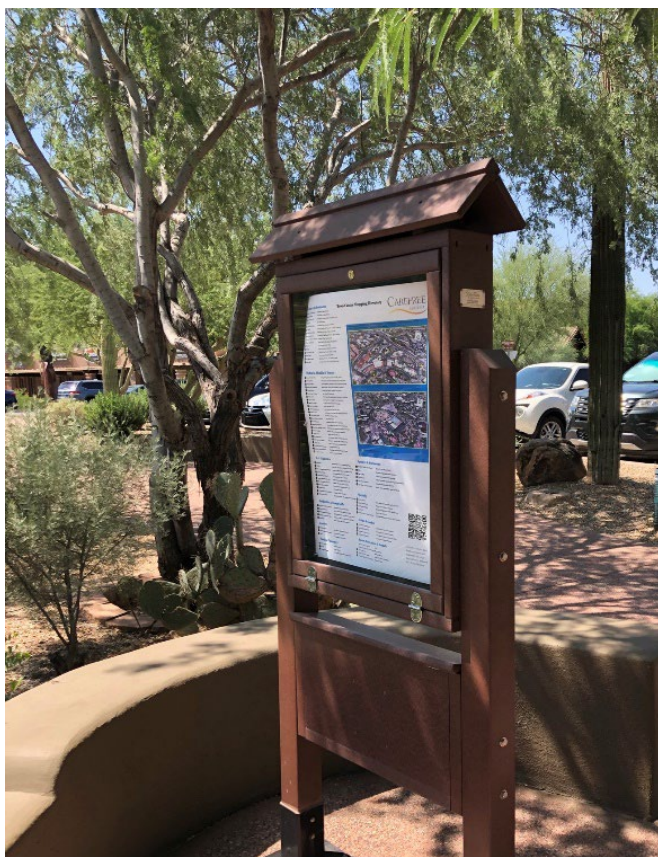
Several informational signs exist within Town Center to direct visitors to key destinations and area businesses. While helpful, these signs are often difficult to read given the amount of information that is conveyed on each sign. In addition, the frames blend with the surrounding landscape making these important wayfinding features difficult to quickly identify from a distance. The temporary look and feel of some of the signs also contributes to an overall appearance of sign clutter that could be minimized through consistent design and messaging throughout Town Center.

Examples of Existing Kiosk Signs
